Industrial Tank Field Report

GROUP INFO: MUSC Health

FACILITY: Building 108 #2 (Pharmacy gen. Tank)

Unit Id : 108-FT-28

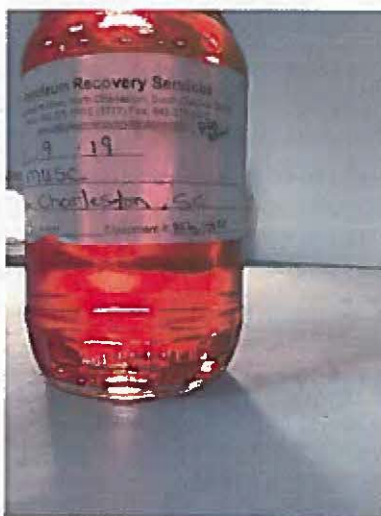
Exterior Tank Condition:

☒ Good ☐ Bad

<input type="checkbox"/> Pre-Clean	<input checked="" type="checkbox"/> Post Clean
<input checked="" type="checkbox"/> None	
<input type="checkbox"/> Bulk Water	
<input type="checkbox"/> Suspended Water	
<input type="checkbox"/> Micro-organisms	
<input type="checkbox"/> Sediments	
<input type="checkbox"/> Rust	
<input type="checkbox"/> Sludge

<input type="checkbox"/> Pre-Clean	<input checked="" type="checkbox"/> Post Clean
<input type="checkbox"/> Refinery Fresh	
<input checked="" type="checkbox"/> Good	
<input type="checkbox"/> Watch Closely	
<input type="checkbox"/> Advanced Aging	
<input type="checkbox"/> Bad-Not Recommended	
<input type="checkbox"/> Severe-Do Not Use

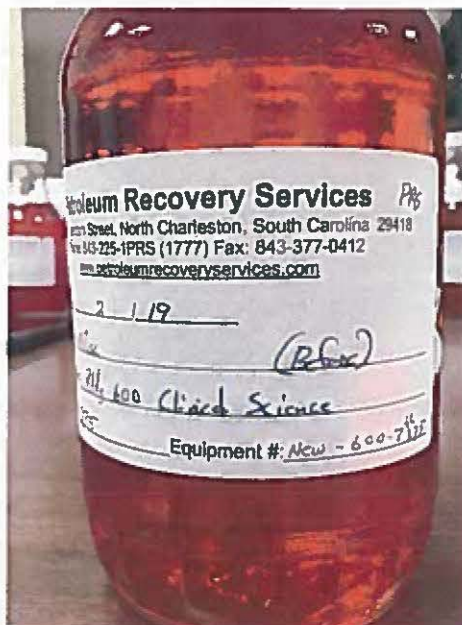
Exterior Tank Condition:

- ☒ Good ☐ Bad
☐ Recommend Inspection

- ☒ Pre-Clean ☐ Post Clean
☒ None
☐ Bulk Water
☐ Suspended Water
☐ Micro-organisms
☐ Sediments
☐ Rust
☐ Sludge

- ☒ Pre-Clean ☐ Post Clean
☐ Refinery Fresh
☒ Good
☐ Watch Closely
☐ Advanced Aging
☐ Bad-Not Recommended
☐ Severe-Do Not Use

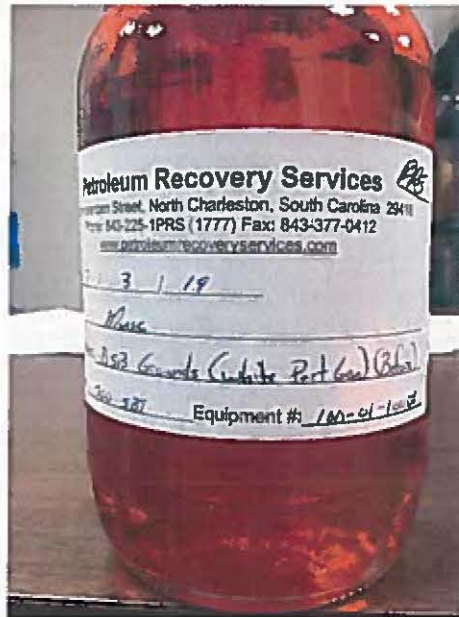
Exterior Tank Condition:

- ☒ Good ☐ Bad
☐ Recommend Inspection

- ☒ Pre-Clean ☐ Post Clean
☐ None
☐ Bulk Water
☐ Suspended Water
☐ Micro-organisms
☒ Sediments
☐ Rust
☐ Sludge

- ☒ Pre-Clean ☐ Post Clean
☐ Refinery Fresh
☒ Good
☐ Watch Closely
☐ Advanced Aging
☐ Bad-Not Recommended
☐ Severe-Do Not Use

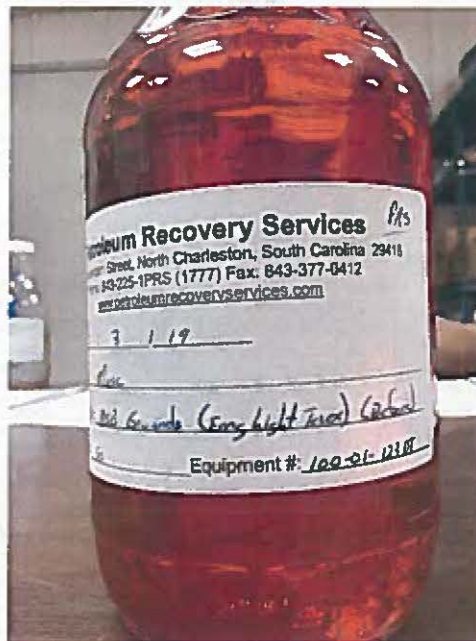
Exterior Tank Condition:

- ☒ Good ☐ Bad
☐ Recommend Inspection

- ☒ Pre-Clean ☐ Post Clean
☐ None
☐ Bulk Water
☐ Suspended Water
☐ Micro-organisms
☒ Sediments
☐ Rust
☐ Sludge

- ☒ Pre-Clean ☐ Post Clean
☐ Refinery Fresh
☒ Good
☐ Watch Closely
☐ Advanced Aging
☐ Bad-Not Recommended
☐ Severe-Do Not Use

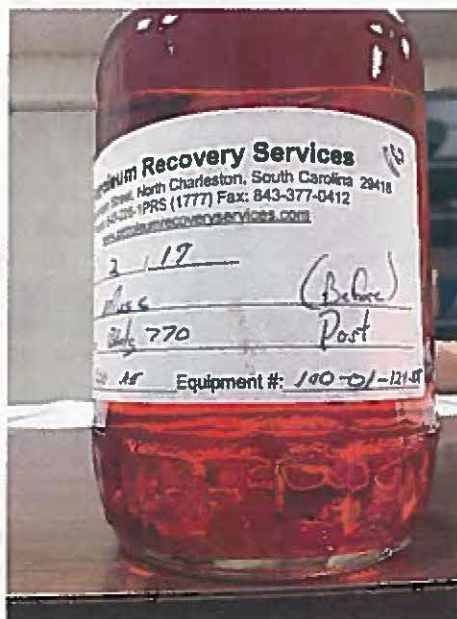
Exterior Tank Condition:

- ☒ Good ☐ Bad
☐ Recommend Inspection

- ☒ Pre-Clean ☐ Post Clean
☐ None
☐ Bulk Water
☐ Suspended Water
☐ Micro-organisms
☒ Sediments
☐ Rust
☐ Sludge

- ☒ Pre-Clean ☐ Post Clean
☐ Refinery Fresh
☒ Good
☐ Watch Closely
☐ Advanced Aging
☐ Bad-Not Recommended
☐ Severe-Do Not Use

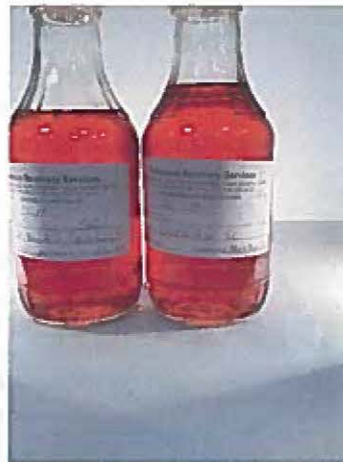
Exterior Tank Condition:

☒ Good ☐ Bad
☐ Recommend Inspection

☒ Pre-Clean ☐ Post Clean
☐ None
☐ Bulk Water
☐ Suspended Water
☐ Micro-organisms
☒ Sediments
☐ Rust
☐ Sludge

☐ Pre-Clean ☒ Post Clean
☐ Refinery Fresh
☒ Good
☐ Watch Closely
☐ Advanced Aging
☐ Bad-Not Recommended
☐ Severe-Do Not Use

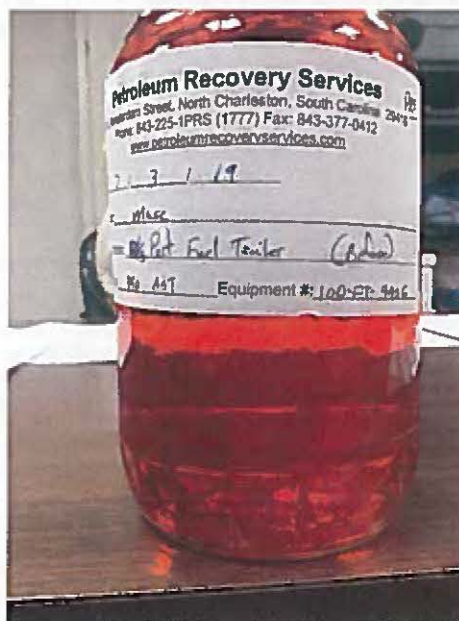
Exterior Tank Condition:

- ☒ Good ☐ Bad
☐ Recommend Inspection

- ☒ Pre-Clean ☐ Post Clean
- ☐ None
☐ Bulk Water
☐ Suspended Water
☐ Micro-organisms
☒ Sediments
☐ Rust
☐ Sludge

- ☒ Pre-Clean ☐ Post Clean
- ☐ Refinery Fresh
☒ Good
☐ Watch Closely
☐ Advanced Aging
☐ Bad-Not Recommended
☐ Severe-Do Not Use

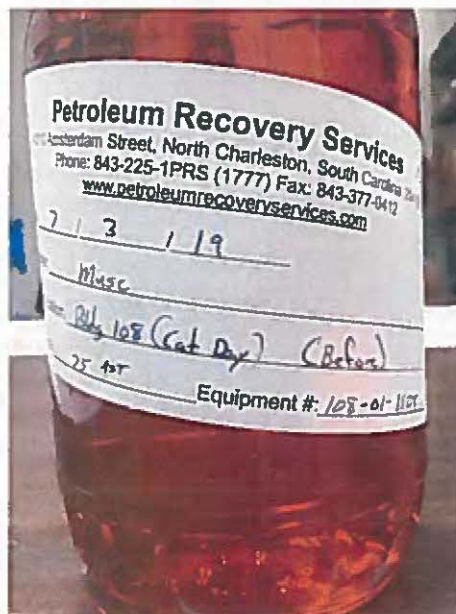
Exterior Tank Condition:

- ☒ Good ☐ Bad
☐ Recommend Inspection

- ☒ Pre-Clean ☐ Post Clean
- ☐ None
☐ Bulk Water
☐ Suspended Water
☐ Micro-organisms
☒ Sediments
☐ Rust
☐ Sludge

- ☒ Pre-Clean ☐ Post Clean
- ☐ Refinery Fresh
☒ Good
☐ Watch Closely
☐ Advanced Aging
☐ Bad-Not Recommended
☐ Severe-Do Not Use

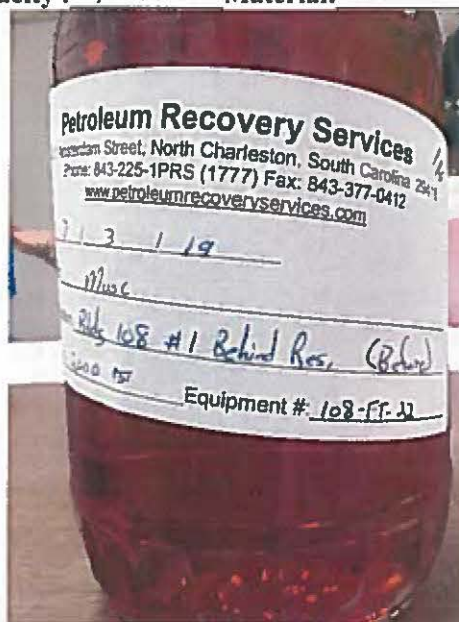
Exterior Tank Condition:

- ☒ Good ☐ Bad
☐ Recommend Inspection

- ☒ Pre-Clean ☐ Post Clean
- ☐ None
☐ Bulk Water
☐ Suspended Water
☐ Micro-organisms
☒ Sediments
☐ Rust
☐ Sludge

- ☒ Pre-Clean ☐ Post Clean
- ☐ Refinery Fresh
☒ Good
☐ Watch Closely
☐ Advanced Aging
☐ Bad-Not Recommended
☐ Severe-Do Not Use

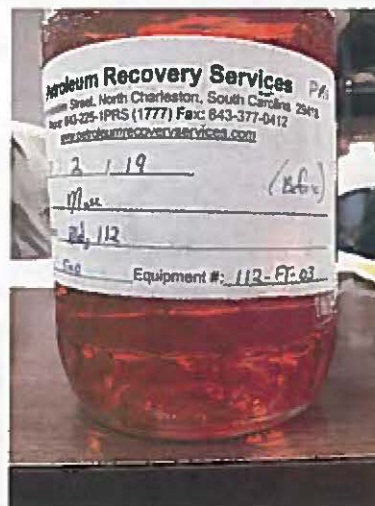
Exterior Tank Condition:

- ☒ Good ☐ Bad
☐ Recommend Inspection

- ☒ Pre-Clean ☐ Post Clean
☐ None
☐ Bulk Water
☐ Suspended Water
☐ Micro-organisms
☒ Sediments
☐ Rust
☐ Sludge

- ☒ Pre-Clean ☐ Post Clean
☐ Refinery Fresh
☒ Good
☐ Watch Closely
☐ Advanced Aging
☐ Bad-Not Recommended
☐ Severe-Do Not Use

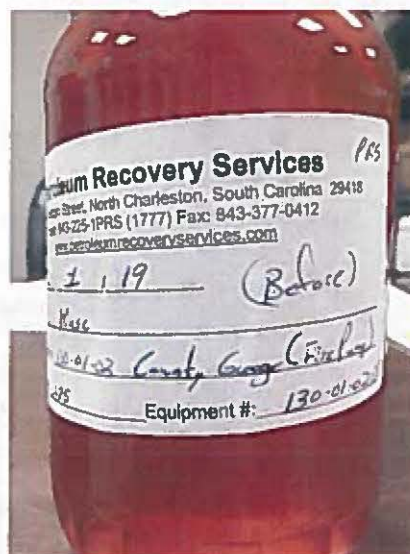
Exterior Tank Condition:

- ☒ Good ☐ Bad
☐ Recommend Inspection

- ☒ Pre-Clean ☐ Post Clean
☐ None
☒ Bulk Water
☐ Suspended Water
☐ Micro-organisms
☒ Sediments
☐ Rust
☐ Sludge

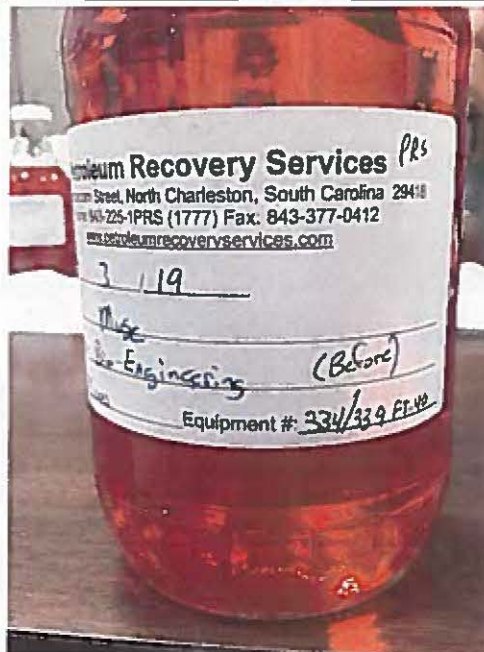
VISUAL FUEL RATING:

- ☒ Pre-Clean ☐ Post Clean
☐ Refinery Fresh
☒ Good
☐ Watch Closely
☐ Advanced Aging
☐ Bad-Not Recommended
☐ Severe-Do Not Use

THIS TANK DOES NOT PASS ASTM D975 "CLEAR & BRIGHT" VISUAL INSPECTION

*Tank cleaning is recommended based on Visual Fuel Inspection ONLY. Lab Report will determine fuel parameters based on ASTM D975 Specifications
