Industrial Tank Field Report

GROUP INFO: MUSC Health DATE: 7-2-19
CUSTOMER: MUSC INFO-OTHER: University Tanks
FACILITY: Building 500
ADDRESS: 118 Jonathan Lucas St. MSC 190, Charleston, SC 29425
CONTACT: Rick Burt, Matthew Long PHONE: 843-323-0432
EMAIL: burtd@musc.edu, Longmat@musc.edu CELL: (843) 792-3531
Unit Id : 500-FT-33 Type : UST Capacity : 20,000 Material: Dsl

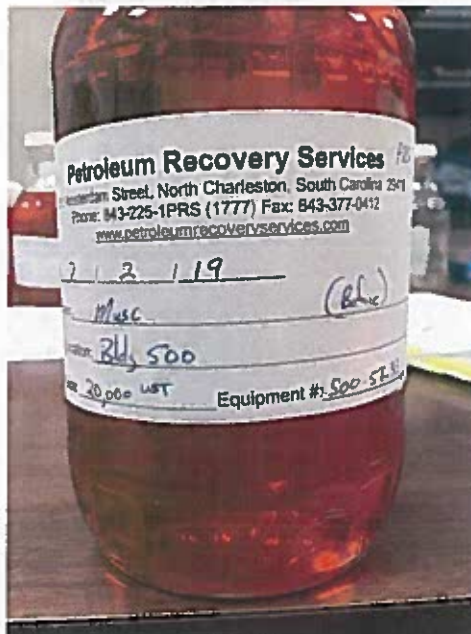
Exterior Tank Condition:

- ☒ Good ☐ Bad
☐ Recommend Inspection

CONTAMINANTS FOUND:

- ☒ Pre-Clean ☐ Post Clean
☐ None
☐ Bulk Water
☐ Suspended Water
☐ Micro-organisms
☒ Sediments
☐ Rust
☐ Sludge

VISUAL FUEL RATING:

- ☒ Pre-Clean ☐ Post Clean
☐ Refinery Fresh
☒ Good
☐ Watch Closely
☐ Advanced Aging
☐ Bad-Not Recommended
☐ Severe-Do Not Use

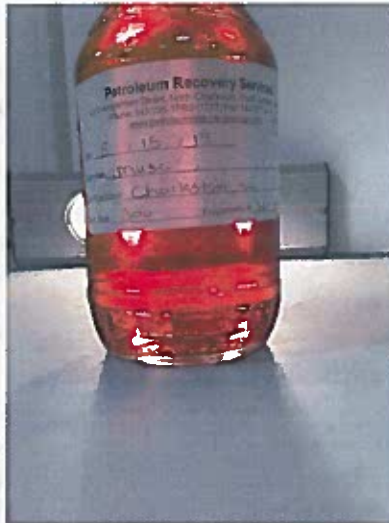
Exterior Tank Condition:

☒ Good ☐ Bad
☐ Recommend Inspection

CONTAMINANTS FOUND:

☐ Pre-Clean ☒ Post Clean
☒ None
☐ Bulk Water
☐ Suspended Water
☐ Micro-organisms
☐ Sediments
☐ Rust
☐ Sludge

☐ Pre-Clean ☒ Post Clean
☐ Refinery Fresh
☒ Good
☐ Watch Closely
☐ Advanced Aging
☐ Bad-Not Recommended
☐ Severe-Do Not Use

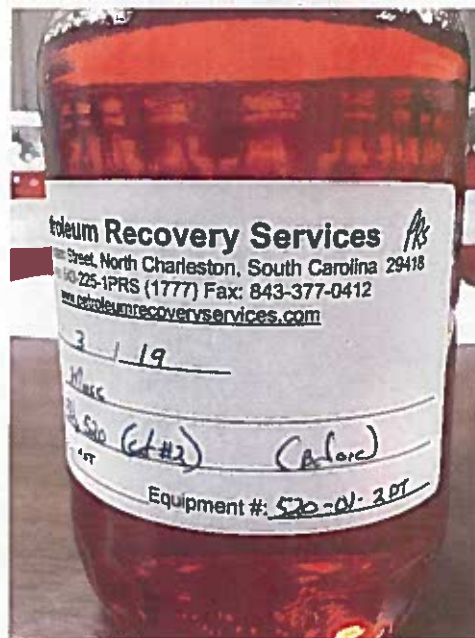
Exterior Tank Condition:

- ☒ Good ☐ Bad
☐ Recommend Inspection

CONTAMINANTS FOUND:

- ☒ Pre-Clean ☐ Post Clean
☐ None
☐ Bulk Water
☐ Suspended Water
☐ Micro-organisms
☒ Sediments
☐ Rust
☐ Sludge

- ☒ Pre-Clean ☐ Post Clean
☐ Refinery Fresh
☒ Good
☐ Watch Closely
☐ Advanced Aging
☐ Bad-Not Recommended
☐ Severe-Do Not Use

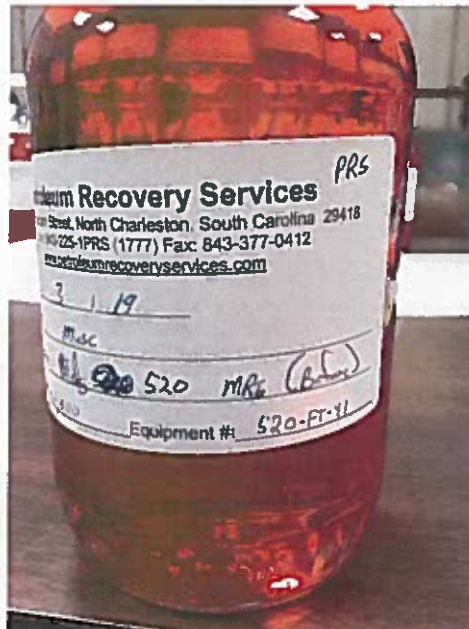
Exterior Tank Condition:

☒ Good ☐ Bad
☐ Recommend Inspection

CONTAMINANTS FOUND:

☒ Pre-Clean ☐ Post Clean
☐ None
☐ Bulk Water
☐ Suspended Water
☐ Micro-organisms
☒ Sediments
☐ Rust
☐ Sludge

☒ Pre-Clean ☐ Post Clean
☐ Refinery Fresh
☒ Good
☐ Watch Closely
☐ Advanced Aging
☐ Bad-Not Recommended
☐ Severe-Do Not Use

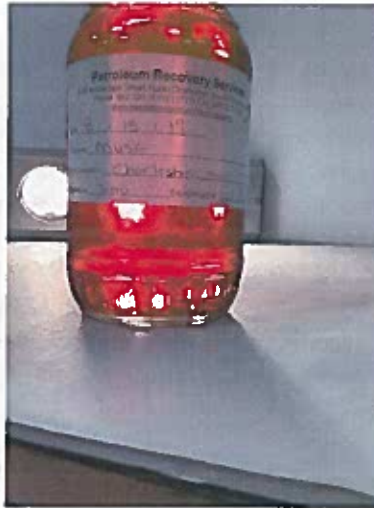
Exterior Tank Condition:

- ☒ Good ☐ Bad
☐ Recommend Inspection

CONTAMINANTS FOUND:

- ☐ Pre-Clean ☒ Post Clean
☒ None
☐ Bulk Water
☐ Suspended Water
☐ Micro-organisms
☐ Sediments
☐ Rust
☐ Sludge

- ☐ Pre-Clean ☒ Post Clean
☐ Refinery Fresh
☒ Good
☐ Watch Closely
☐ Advanced Aging
☐ Bad-Not Recommended
☐ Severe-Do Not Use

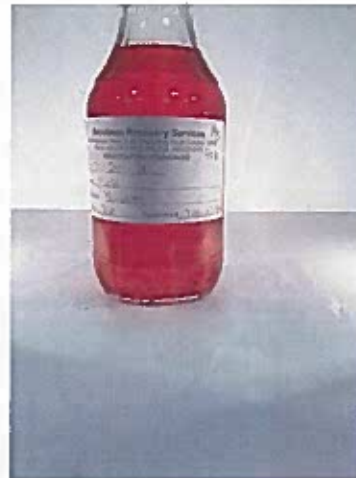
Exterior Tank Condition:

- ☒ Good ☐ Bad
☐ Recommend Inspection

CONTAMINANTS FOUND:

- ☒ Pre-Clean ☐ Post Clean
☒ None
☐ Bulk Water
☐ Suspended Water
☐ Micro-organisms
☐ Sediments
☐ Rust
☐ Sludge

- ☒ Pre-Clean ☐ Post Clean
☐ Refinery Fresh
☒ Good
☐ Watch Closely
☐ Advanced Aging
☐ Bad-Not Recommended
☐ Severe-Do Not Use

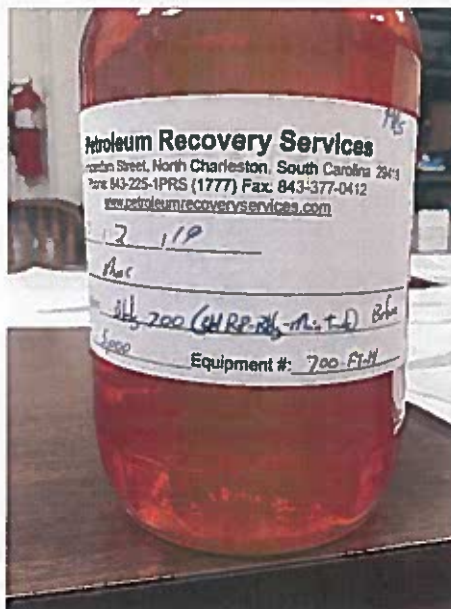
Exterior Tank Condition:

- ☒ Good ☐ Bad
☐ Recommend Inspection

CONTAMINANTS FOUND:

- ☒ Pre-Clean ☐ Post Clean
☐ None
☐ Bulk Water
☐ Suspended Water
☐ Micro-organisms
☒ Sediments
☐ Rust
☐ Sludge

- ☒ Pre-Clean ☐ Post Clean
☐ Refinery Fresh
☒ Good
☐ Watch Closely
☐ Advanced Aging
☐ Bad-Not Recommended
☐ Severe-Do Not Use

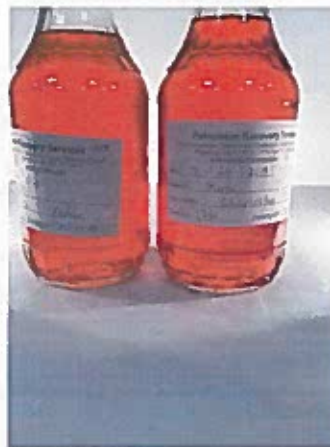
Exterior Tank Condition:

☒ Good ☐ Bad

☐ None
☐ Bulk Water
☐ Suspended Water
☐ Micro-organisms
☒ Sediments
☐ Rust
☐ Sludge

☐ Refinery Fresh
☒ Good
☐ Watch Closely
☐ Advanced Aging
☐ Bad-Not Recommended
☐ Severe-Do Not Use

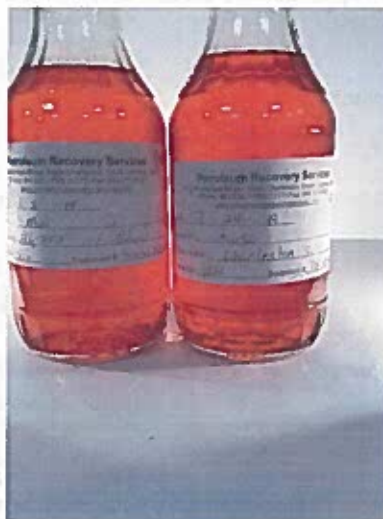
Exterior Tank Condition:

☒ Good ☐ Bad

☐ None
☐ Bulk Water
☐ Suspended Water
☐ Micro-organisms
☒ Sediments
☐ Rust
☐ Sludge

☐ Refinery Fresh
☒ Good
☐ Watch Closely
☐ Advanced Aging
☐ Bad-Not Recommended
☐ Severe-Do Not Use

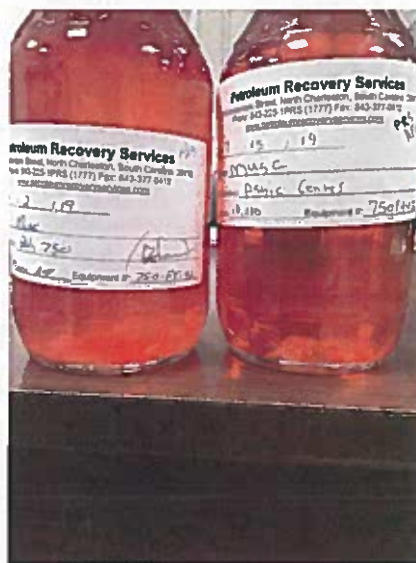
Exterior Tank Condition:

☒ Good ☐ Bad

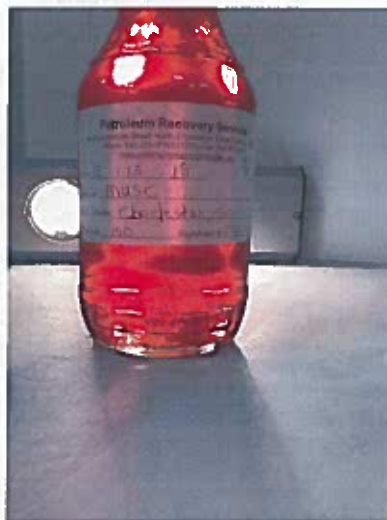
Exterior Tank Condition:

☒ Good ☐ Bad
☐ Recommend Inspection

CONTAMINANTS FOUND:

☐ Pre-Clean ☒ Post Clean
☒ None
☐ Bulk Water
☐ Suspended Water
☐ Micro-organisms
☐ Sediments
☐ Rust
☐ Sludge

☐ Pre-Clean ☒ Post Clean
☐ Refinery Fresh
☒ Good
☐ Watch Closely
☐ Advanced Aging
☐ Bad-Not Recommended
☐ Severe-Do Not Use

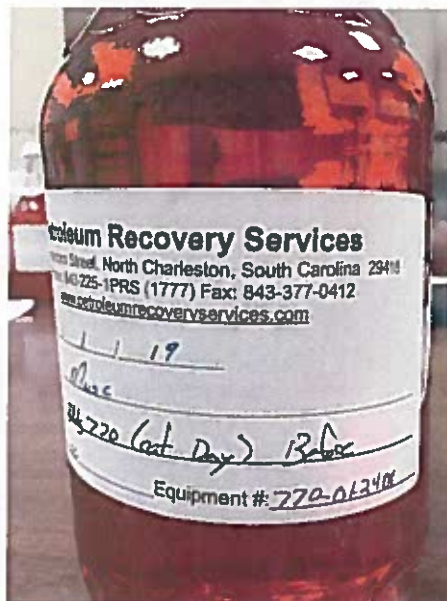
Exterior Tank Condition:

- ☒ Good ☐ Bad
☐ Recommend Inspection

CONTAMINANTS FOUND:

- ☒ Pre-Clean ☐ Post Clean
☐ None
☐ Bulk Water
☐ Suspended Water
☐ Micro-organisms
☒ Sediments
☐ Rust
☐ Sludge

- ☒ Pre-Clean ☐ Post Clean
☐ Refinery Fresh
☒ Good
☐ Watch Closely
☐ Advanced Aging
☐ Bad-Not Recommended
☐ Severe-Do Not Use

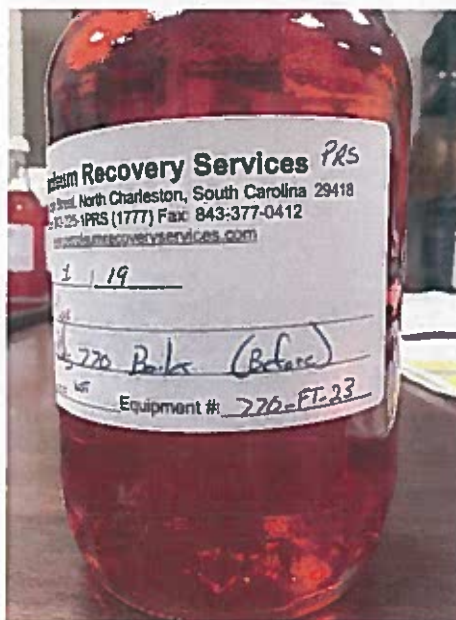
Exterior Tank Condition:

- ☒ Good ☐ Bad
☐ Recommend Inspection

CONTAMINANTS FOUND:

- ☒ Pre-Clean ☐ Post Clean
☐ None
☐ Bulk Water
☐ Suspended Water
☐ Micro-organisms
☒ Sediments
☐ Rust
☐ Sludge

- ☒ Pre-Clean ☐ Post Clean
☐ Refinery Fresh
☒ Good
☐ Watch Closely
☐ Advanced Aging
☐ Bad-Not Recommended
☐ Severe-Do Not Use

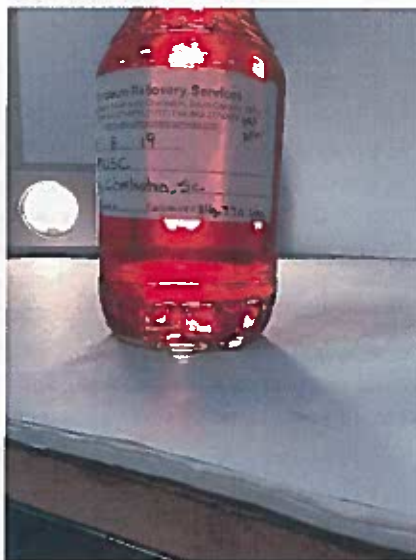
Exterior Tank Condition:

☒ Good ☐ Bad

☒ None
Bulk Water
Suspended Water
Micro-organisms
Sediments
Rust
Sludge

Refinery Fresh
☒ Good
Watch Closely
Advanced Aging
Bad-Not Recommended
Severe-Do Not Use

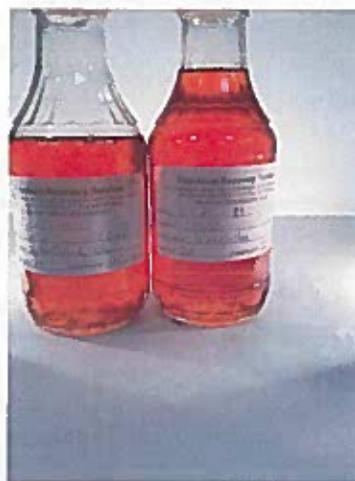
☒ Good ☐ Bad

☐ None
☐ Bulk Water
☐ Suspended Water
☐ Micro-organisms
☒ Sediments
☐ Rust
☐ Sludge

☐ Refinery Fresh
☒ Good
☐ Watch Closely
☐ Advanced Aging
☐ Bad-Not Recommended
☐ Severe-Do Not Use

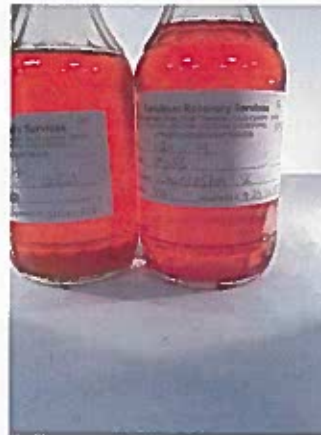
☒ Good ☐ Bad
☐ Recommend Inspection

☒ Pre-Clean ☐ Post Clean
☐ None
☐ Bulk Water
☒ Suspended Water
☐ Micro-organisms
☒ Sediments
☐ Rust
☐ Sludge

☐ Pre-Clean ☒ Post Clean
☐ Refinery Fresh
☒ Good
☐ Watch Closely
☐ Advanced Aging
☐ Bad-Not Recommended
☐ Severe-Do Not Use

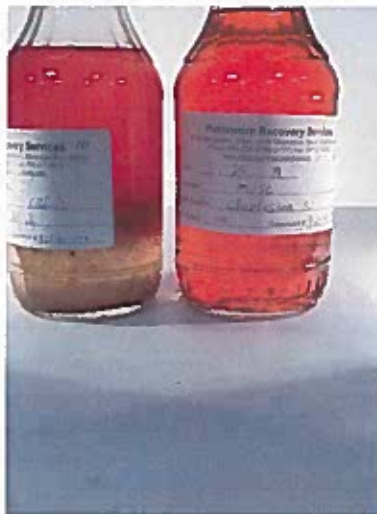
☒ Good ☐ Bad
☐ Recommend Inspection

☒ Pre-Clean ☐ Post Clean
☐ None
☐ Bulk Water
☒ Suspended Water
☒ Micro-organisms
☒ Sediments
☐ Rust
☐ Sludge

☐ Pre-Clean ☒ Post Clean
☐ Refinery Fresh
☒ Good
☐ Watch Closely
☐ Advanced Aging
☐ Bad-Not Recommended
☐ Severe-Do Not Use
