GROUP INFO: MUSC Health DATE: 7-11-19
 CUSTOMER: MUSC INFO-OTHER: Hospital tanks
 FACILITY: Building 358 SCEP (Sabin St) UST 15k (358-0150-UST-15)
 ADDRESS: 111 Jonathan Lucas St. MSC 190, Charleston, SC 29425
 CONTACT: Rick Burt, Matthew Long PHONE: 843-323-0425
 EMAIL: burtd@musc.edu, Longmat@musc.edu CELL: (843) 792-3524
 Unit Id : 358-30822 Type : UST Capacity : 15,000 Material: Dsl

Sample Taken From: 358-30822
 Sample ID: 358-30822
 PO: 632498
 WO: MUSC - Hospital - Post

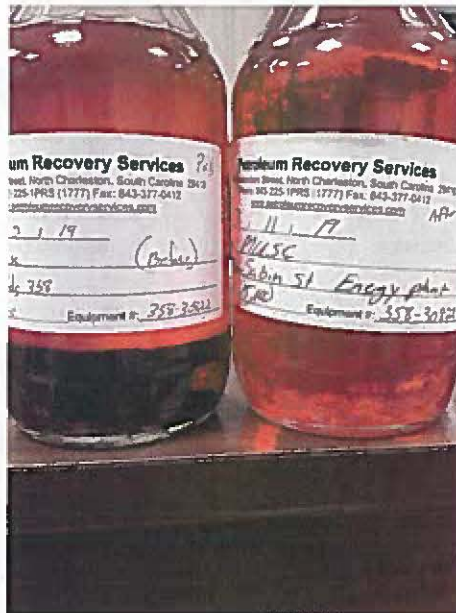
- Pre-Clean Post Clean
- None
 Bulk Water
 Suspended Water
 Micro-organisms
 Sediments
 Rust
 Sludge

- Pre-Clean Post Clean
- Refinery Fresh
 Good
 Watch Closely
 Advanced Aging
 Bad-Not Recommended
 Severe-Do Not Use

THIS TANK DOES NOT PASS ASTM D975 "CLEAR & BRIGHT" VISUAL INSPECTION

Picture of the before cleaning sample is on the left and the after cleaning sample is on the right

**Tank cleaning is recommended based on Visual Fuel Inspection ONLY. Lab Report will determine fuel parameters based on ASTM D975 Specifications*

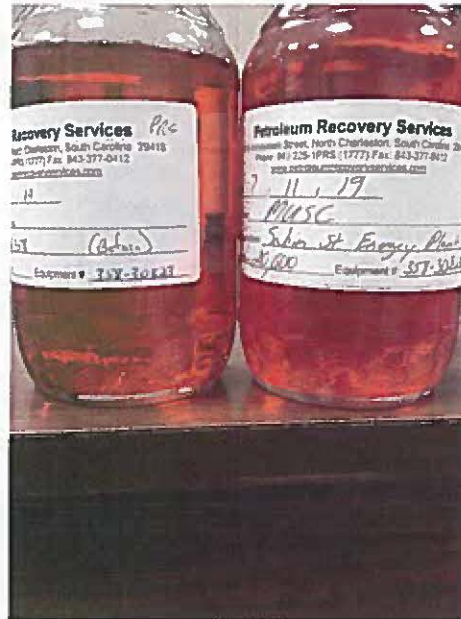
- Pre-Clean Post Clean
- None
 Bulk Water
 Suspended Water
 Micro-organisms
 Sediments
 Rust
 Sludge

- Pre-Clean Post Clean
- Refinery Fresh
 Good
 Watch Closely
 Advanced Aging
 Bad-Not Recommended
 Severe-Do Not Use

**Tank cleaning is recommended based on Visual Fuel Inspection ONLY. Lab Report will determine fuel parameters based on ASTM D975 Specifications*

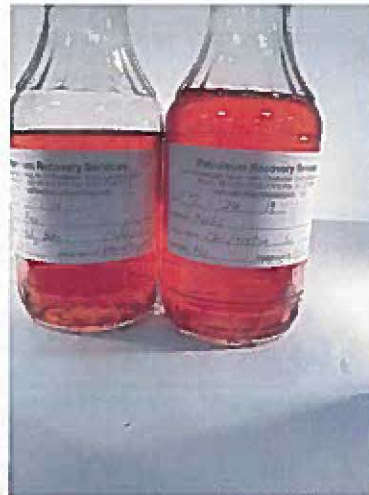
- Pre-Clean Post Clean
 None
 Bulk Water
 Suspended Water
 Micro-organisms
 Sediments
 Rust
 Sludge

- Pre-Clean Post Clean
 Refinery Fresh
 Good
 Watch Closely
 Advanced Aging
 Bad-Not Recommended
 Severe-Do Not Use

**Tank cleaning is recommended based on Visual Fuel Inspection ONLY. Lab Report will determine fuel parameters based on ASTM D975 Specifications*

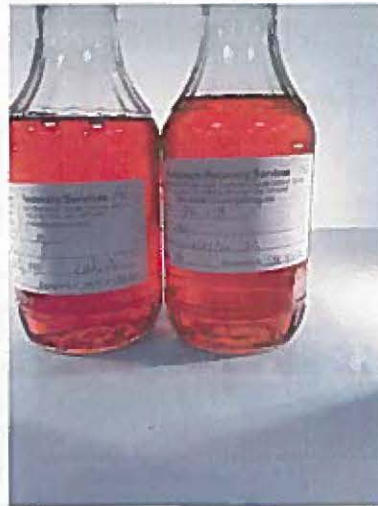
- Pre-Clean Post Clean
- None
- Bulk Water
- Suspended Water
- Micro-organisms
- Sediments
- Rust
- Sludge

- Pre-Clean Post Clean
- Refinery Fresh
- Good
- Watch Closely
- Advanced Aging
- Bad-Not Recommended
- Severe-Do Not Use

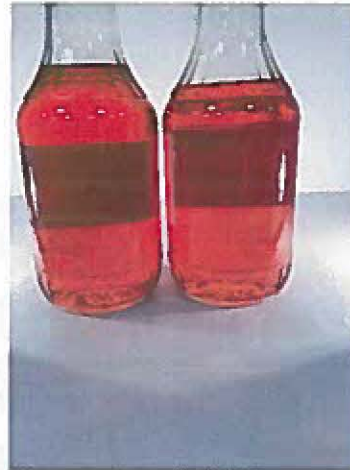
- Pre-Clean Post Clean
 None
 Bulk Water
 Suspended Water
 Micro-organisms
 Sediments
 Rust
 Sludge

- Pre-Clean Post Clean
 Refinery Fresh
 Good
 Watch Closely
 Advanced Aging
 Bad-Not Recommended
 Severe-Do Not Use

**Tank cleaning is recommended based on Visual Fuel Inspection ONLY. Lab Report will determine fuel parameters based on ASTM D975 Specifications*

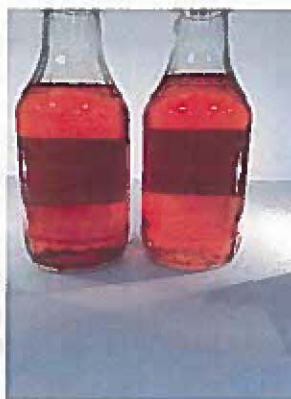
- Pre-Clean Post Clean
 None
 Bulk Water
 Suspended Water
 Micro-organisms
 Sediments
 Rust
 Sludge

- Pre-Clean Post Clean
 Refinery Fresh
 Good
 Watch Closely
 Advanced Aging
 Bad-Not Recommended
 Severe-Do Not Use

**Tank cleaning is recommended based on Visual Fuel Inspection ONLY. Lab Report will determine fuel parameters based on ASTM D975 Specifications*

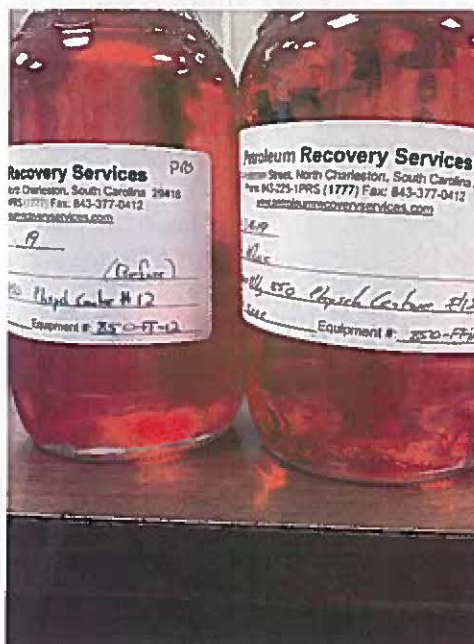
- Pre-Clean Post Clean
 None
 Bulk Water
 Suspended Water
 Micro-organisms
 Sediments
 Rust
 Sludge

- Pre-Clean Post Clean
 Refinery Fresh
 Good
 Watch Closely
 Advanced Aging
 Bad-Not Recommended
 Severe-Do Not Use

*Tank cleaning is recommended based on Visual Fuel Inspection ONLY. Lab Report will determine fuel parameters based on ASTM D975 Specifications

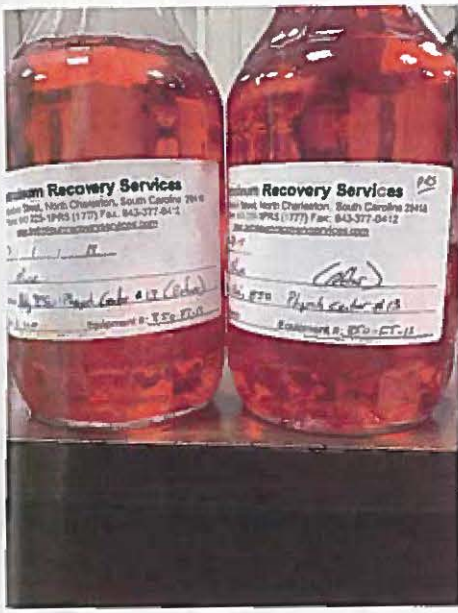
- Pre-Clean
- Post Clean
- None
- Bulk Water
- Suspended Water
- Micro-organisms
- Sediments
- Rust
- Sludge

- Pre-Clean
- Post Clean
- Refinery Fresh
- Good
- Watch Closely
- Advanced Aging
- Bad-Not Recommended
- Severe-Do Not Use

THIS TANK FAILS ASTM D975 "CLEAR & BRIGHT"

*Tank cleaned based on Visual Fuel Inspection ONLY. Lab Report will determine fuel parameters based on ASTM D975 Specifications

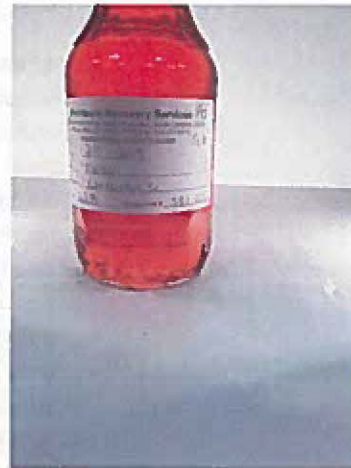
- Pre-Clean Post Clean
- None
- Bulk Water
- Suspended Water
- Micro-organisms
- Sediments
- Rust
- Sludge

- Pre-Clean Post Clean
- Refinery Fresh
- Good
- Watch Closely
- Advanced Aging
- Bad-Not Recommended
- Severe-Do Not Use

**Tank cleaning is recommended based on Visual Fuel Inspection ONLY. Lab Report will determine fuel parameters based on ASTM D975 Specifications*

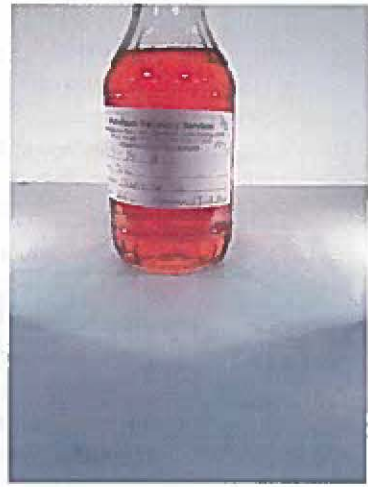
- Pre-Clean Post Clean
- None
- Bulk Water
- Suspended Water
- Micro-organisms
- Sediments
- Rust
- Sludge

- Pre-Clean Post Clean
- Refinery Fresh
- Good
- Watch Closely
- Advanced Aging
- Bad-Not Recommended
- Severe-Do Not Use

**Tank cleaning is recommended based on Visual Fuel Inspection ONLY. Lab Report will determine fuel parameters based on ASTM D975 Specifications*

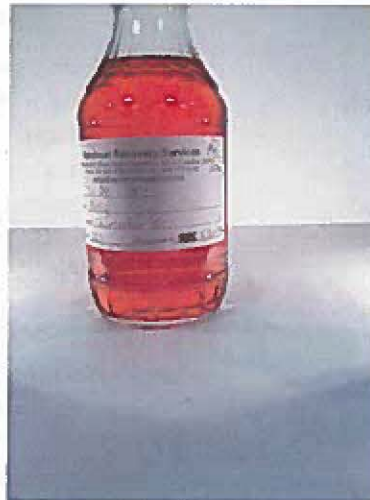
- Pre-Clean Post Clean
- None
- Bulk Water
- Suspended Water
- Micro-organisms
- Sediments
- Rust
- Sludge

- Pre-Clean Post Clean
- Refinery Fresh
- Good
- Watch Closely
- Advanced Aging
- Bad-Not Recommended
- Severe-Do Not Use

**Tank cleaning is recommended based on Visual Fuel Inspection ONLY. Lab Report will determine fuel parameters based on ASTM D975 Specifications*

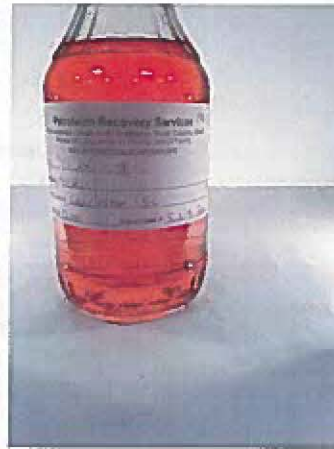
-
- Pre-Clean
-
- Post Clean
-
-
- None
-
-
- Bulk Water
-
-
- Suspended Water
-
-
- Micro-organisms
-
-
- Sediments
-
-
- Rust
-
-
- Sludge

-
- Pre-Clean
-
- Post Clean
-
-
- Refinery Fresh
-
-
- Good
-
-
- Watch Closely
-
-
- Advanced Aging
-
-
- Bad-Not Recommended
-
-
- Severe-Do Not Use

THIS TANK DOES NOT PASS ASTM D975 "CLEAR & BRIGHT" VISUAL INSPECTION
**Tank cleaning is recommended based on Visual Fuel Inspection ONLY. Lab Report will determine fuel parameters based on ASTM D975 Specifications*

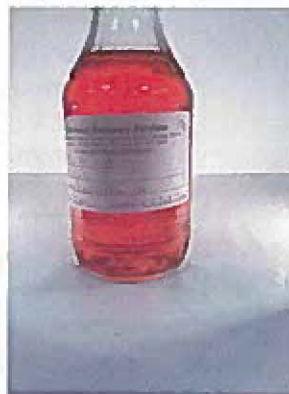
- Pre-Clean Post Clean
- None
- Bulk Water
- Suspended Water
- Micro-organisms
- Sediments
- Rust
- Sludge

- Pre-Clean Post Clean
- Refinery Fresh
- Good
- Watch Closely
- Advanced Aging
- Bad-Not Recommended
- Severe-Do Not Use

**Tank cleaning is recommended based on Visual Fuel Inspection ONLY. Lab Report will determine fuel parameters based on ASTM D975 Specifications*
